**SPECIAL REPORT**  
**Glaciers and Mining Series**

**Los Azules – Minera Andes**  
**(McEwen Mining of Canada)**

**Risks and Impacts to Rock Glaciers**  
**and Periglacial Environments**

**San Juan, Argentina**  
**May 2012**

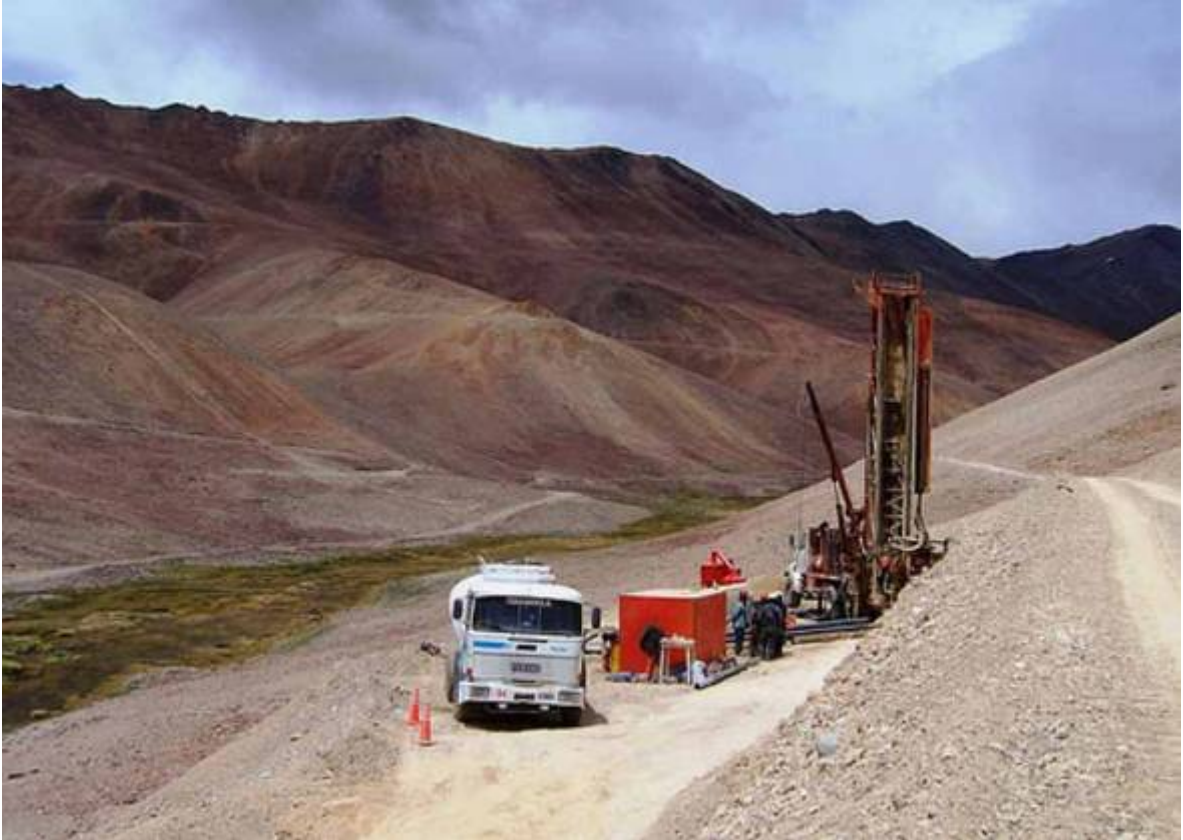
Drill Rig Adjacent to Wetland at Los Azules. This is a typical image of roads and drill platforms introduced by mining companies. These are very visible in satellite imagery as can be seen through *Google Earth*.  
Photo: Minera Andes

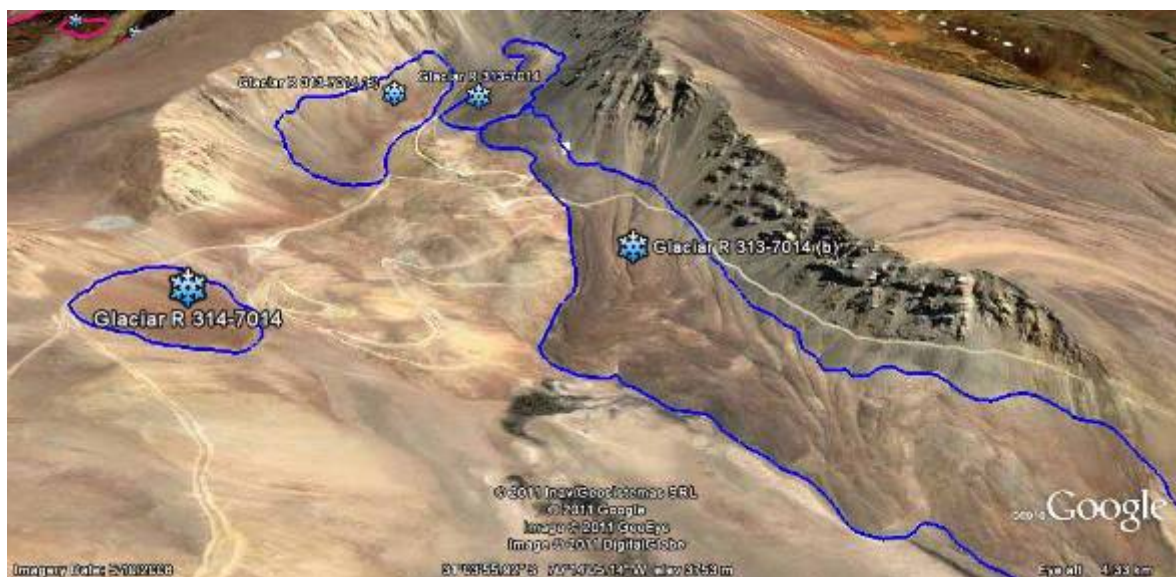
In the picture below, we can see four glaciers at the Los Azules mining project site that have suffered precisely such impact. The image can be seen through *Google Earth* by copying and pasting this precise address in the *Google Earth* search box:

The Los Azules exploratory road enters the image through the right hand side, and then proceeds to cut through the root area of the rock glacier delineated in blue (which feeds the glacier with water and rock debris) advancing down the mountain side. It then crosses the small valley and runs alongside another rock glacier, and then before exiting the image on the left hand side, also cuts through the root area of the other glacier.

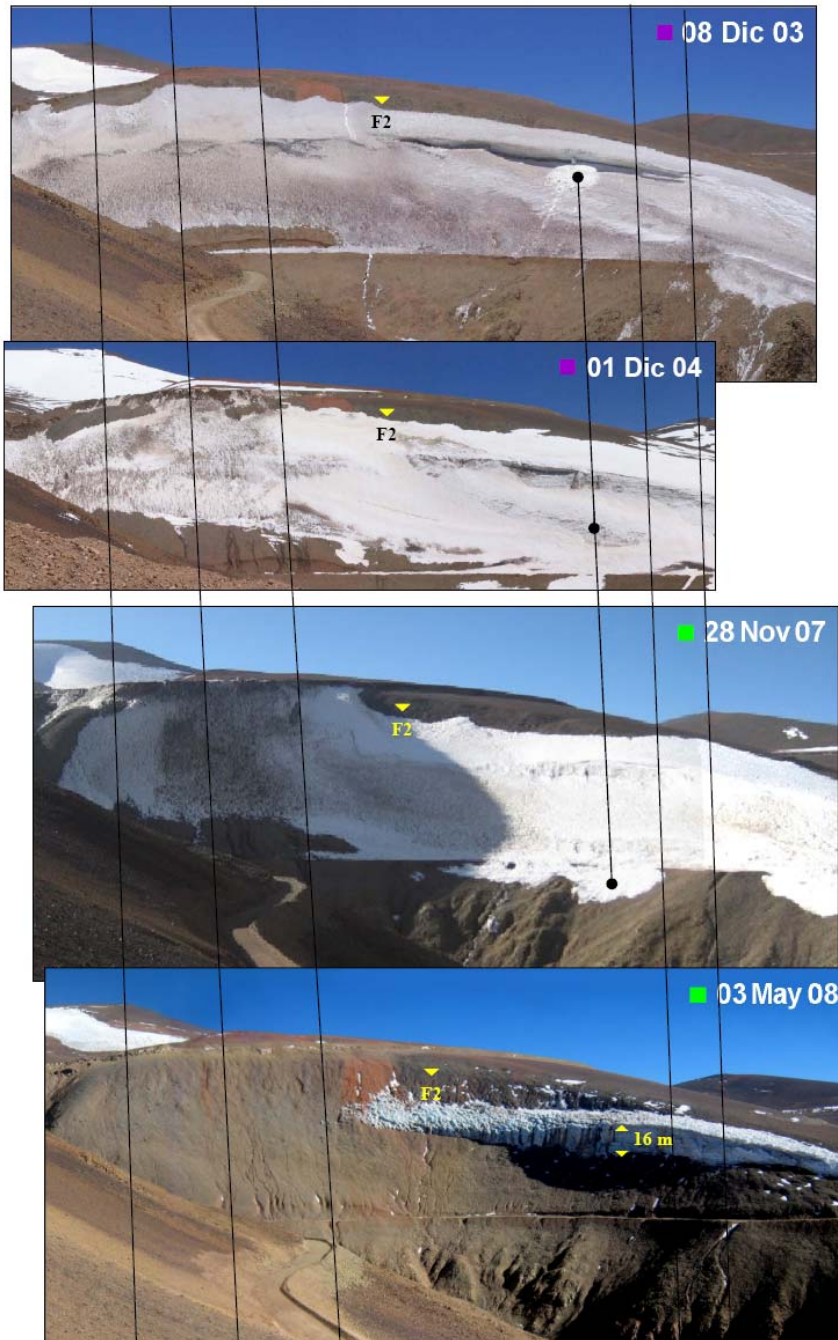
Near total reduction by 2008 of the Almirante Brown Inferior due to Barrick's road impact

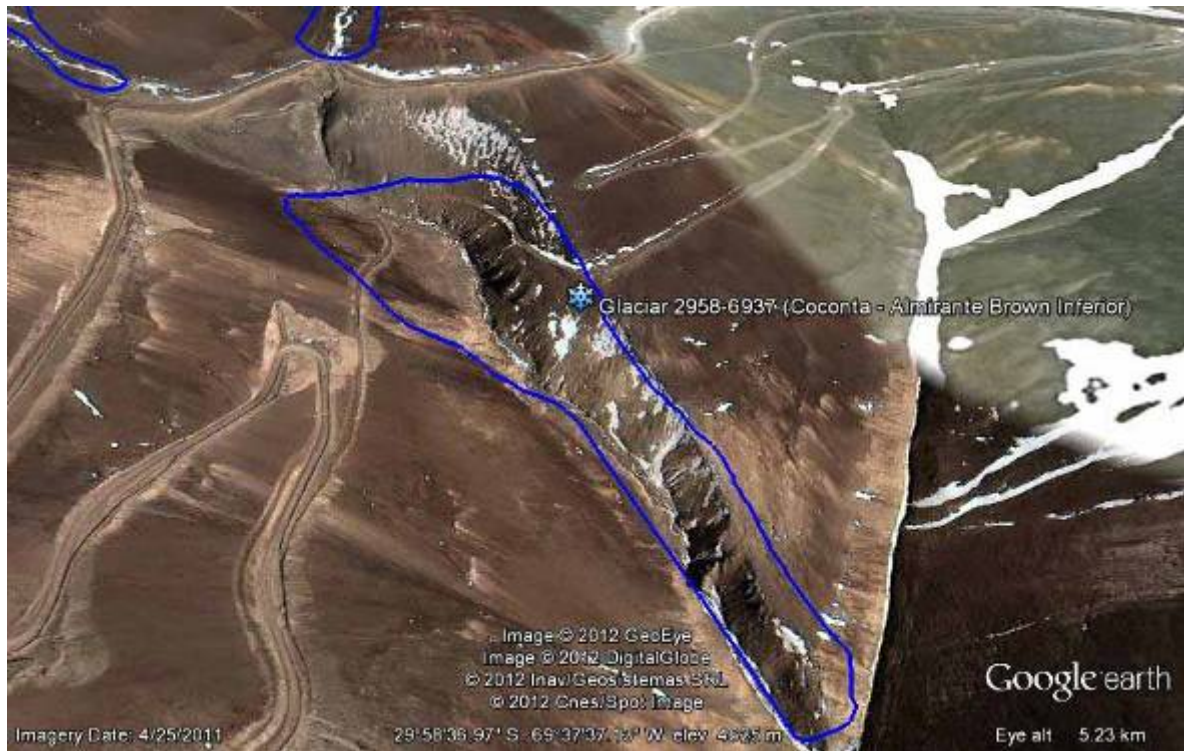
The Almirante Brown Inferior Glacier on the Conconta Pass completely disappeared since Barrick introduced an access road dissecting the glacier. The blue polygon marks the past presence of the glacier.

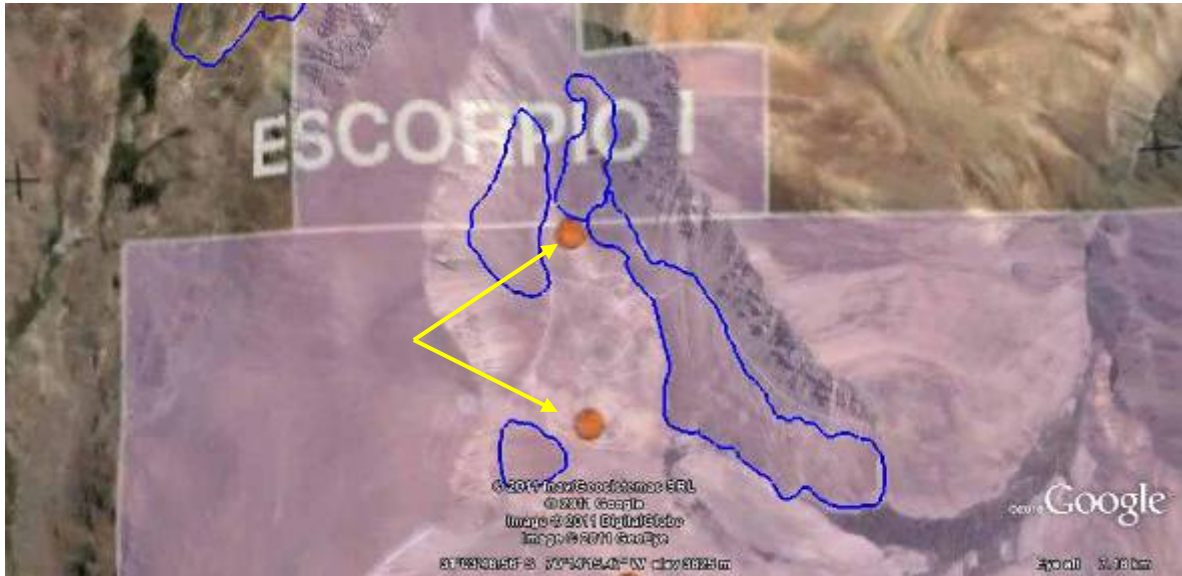
Superimposed Drilling Map and Google Earth Image Reveals Drilling adjacent to Four Rock Glaciers

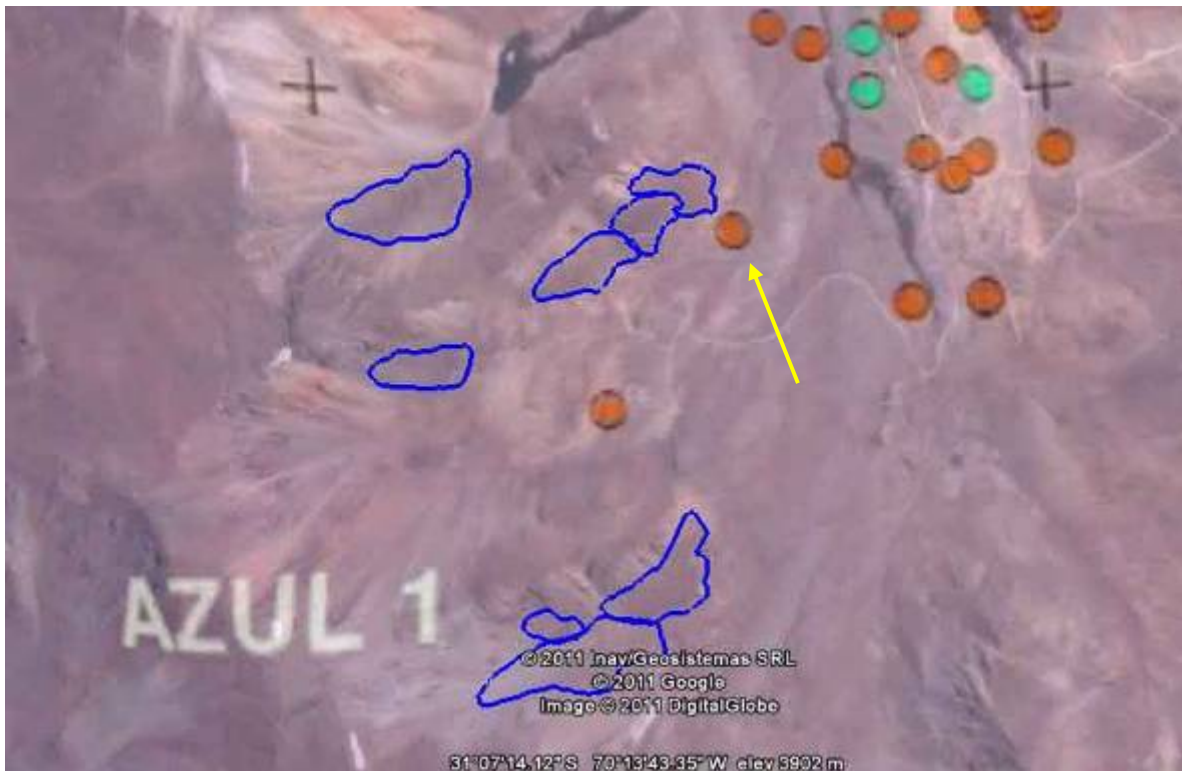
Superimposed Drilling Map and Google Earth Image Reveals Drilling adjacent to three Rock Glaciers

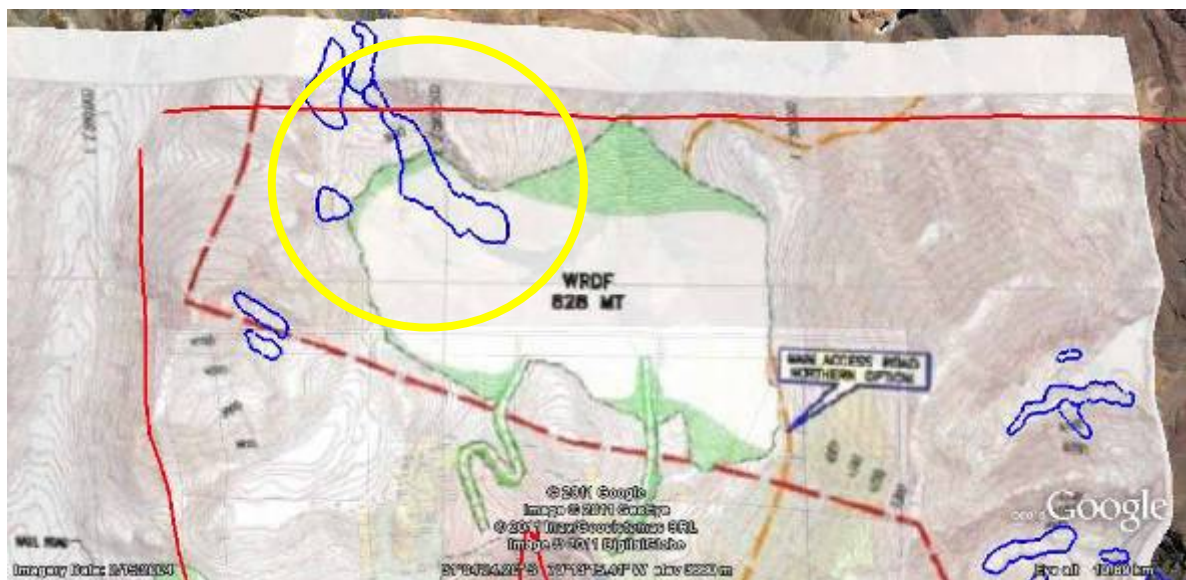
Below is option one for the waste site, there are two glaciers affected by the site choice, one which is inside the waste site (rock glacier 313-7014 (b)), and the other tangential to it (rock glacier 314-7014). The reader can find these glaciers utilizing the *Google Earth* coordinates in our glacier inventory in the annex. The project map transparency can be downloaded at:<sup>34</sup>

Yellow circle highlights rock glacier inside waste facility. This ice glacier would be destroyed by project design.

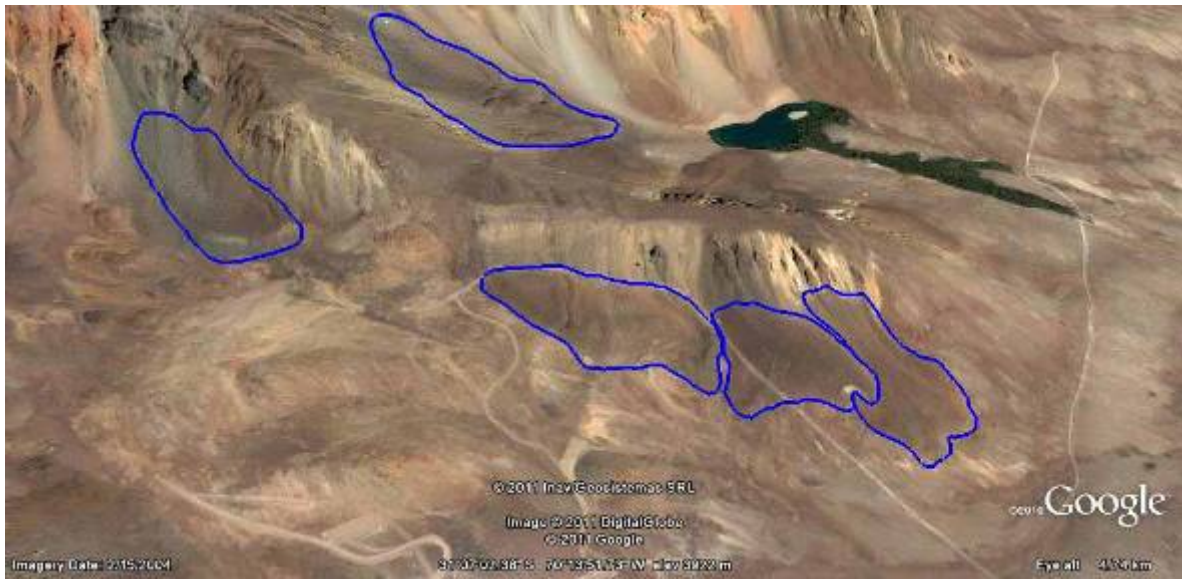
Glacier Impact of Mining Activity at Los Azules. Viewable at: 31°06'58.42" S 70°13'42.45" W

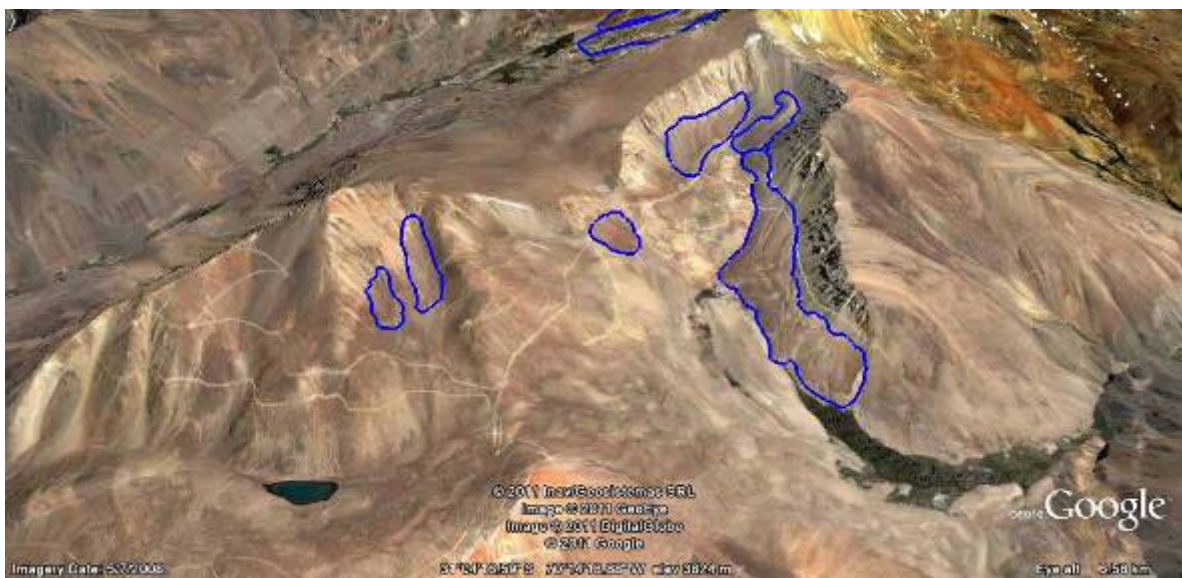
Glacier Impact of Mining Activity at Los Azules. Viewable at: 31°04'16.59" S 70°14'18.88" W

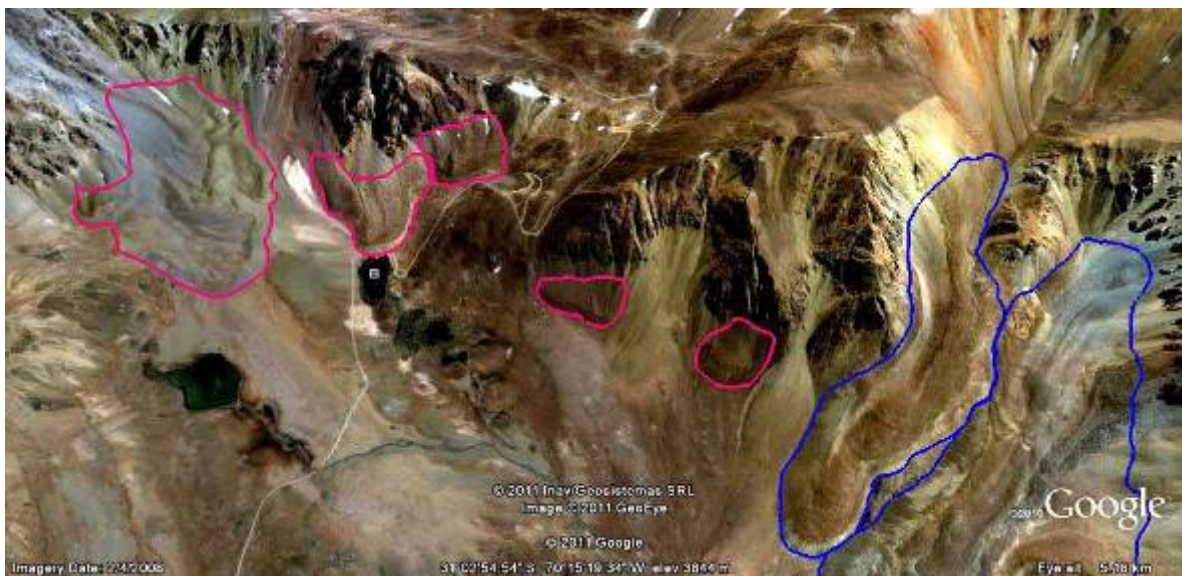
Glacier Impact of Mining Activity at Los Azules. Viewable at: 31°02'54.54" S 70°15'19.34" W

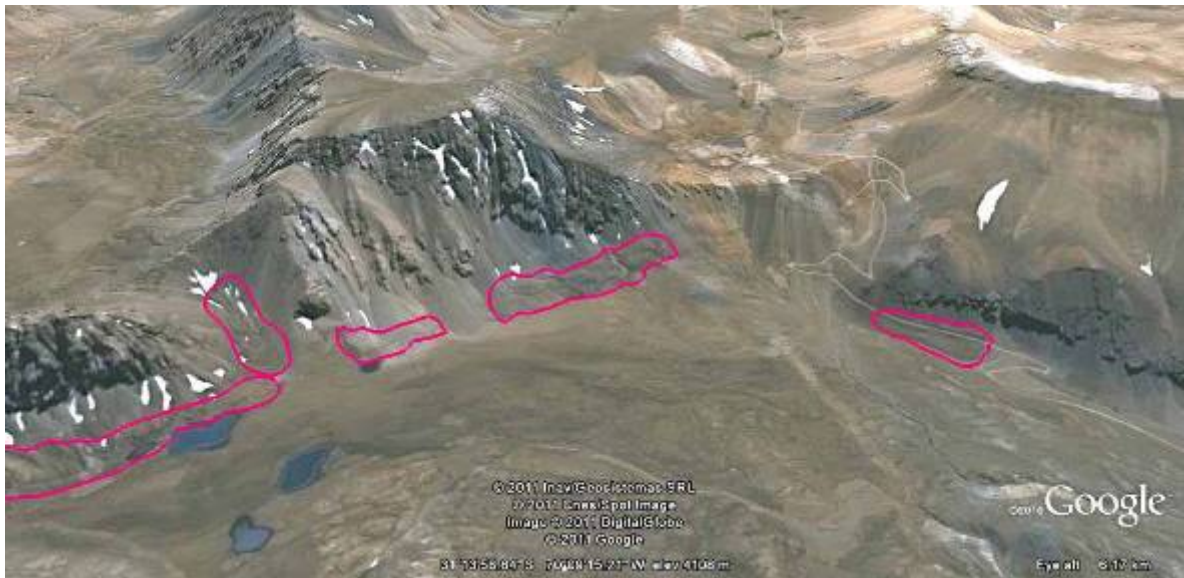
Glacier Impact of Mining Activity at Los Azules. Viewable at: 31°13'58.64" S 70°09'15.21" W

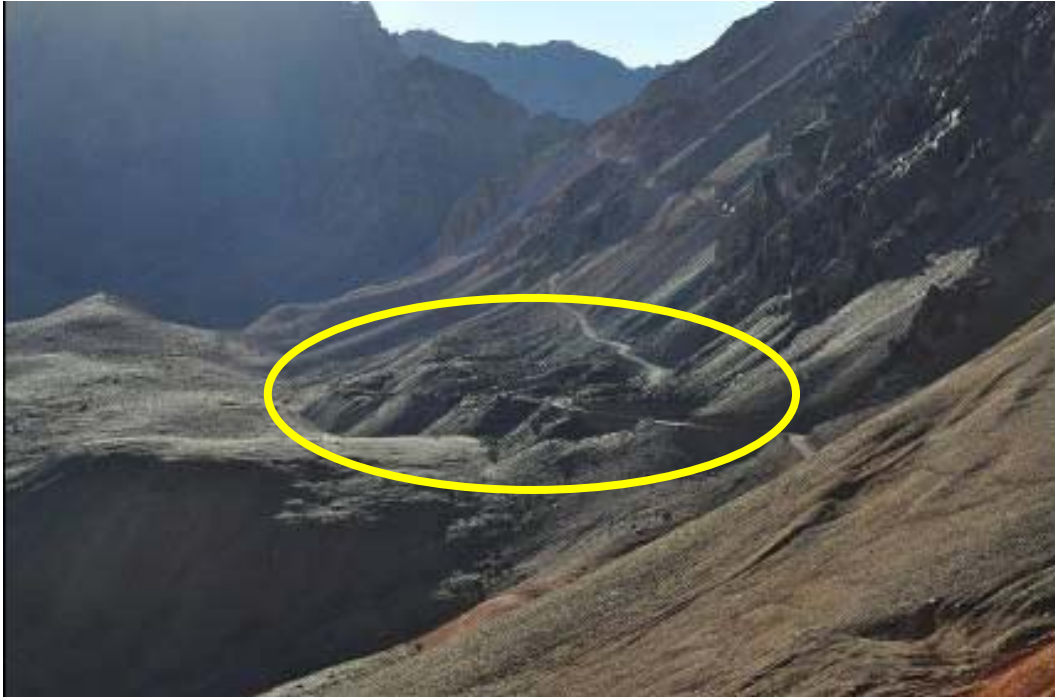
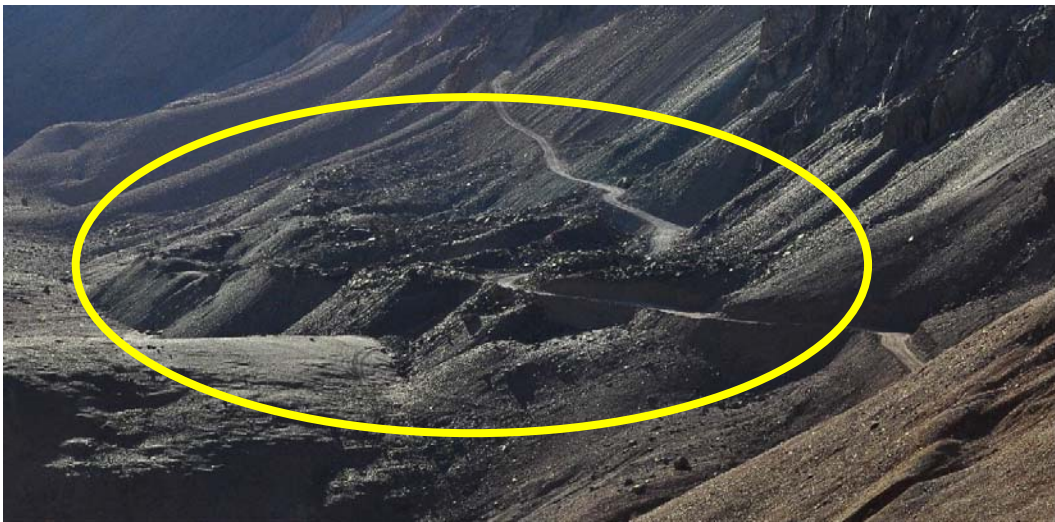
In the image we can see how mining access roads have been built with absolute disregard for rock glaciers in the terrain. The yellow ovals indicate the rock glaciers. We can expect that the rock glaciers below these roads will be strangled and eventually destroyed by the insertion of these roads in the critical zone where the glacier feeds from water and snow coming off of the mountainside. Further, introducing roads on a glacier is not a safe venture as glaciers move and could collapse with heavy weight placed on the surface, such as that of a mining truck. This is an environmental and human hazard for anyone using this road.

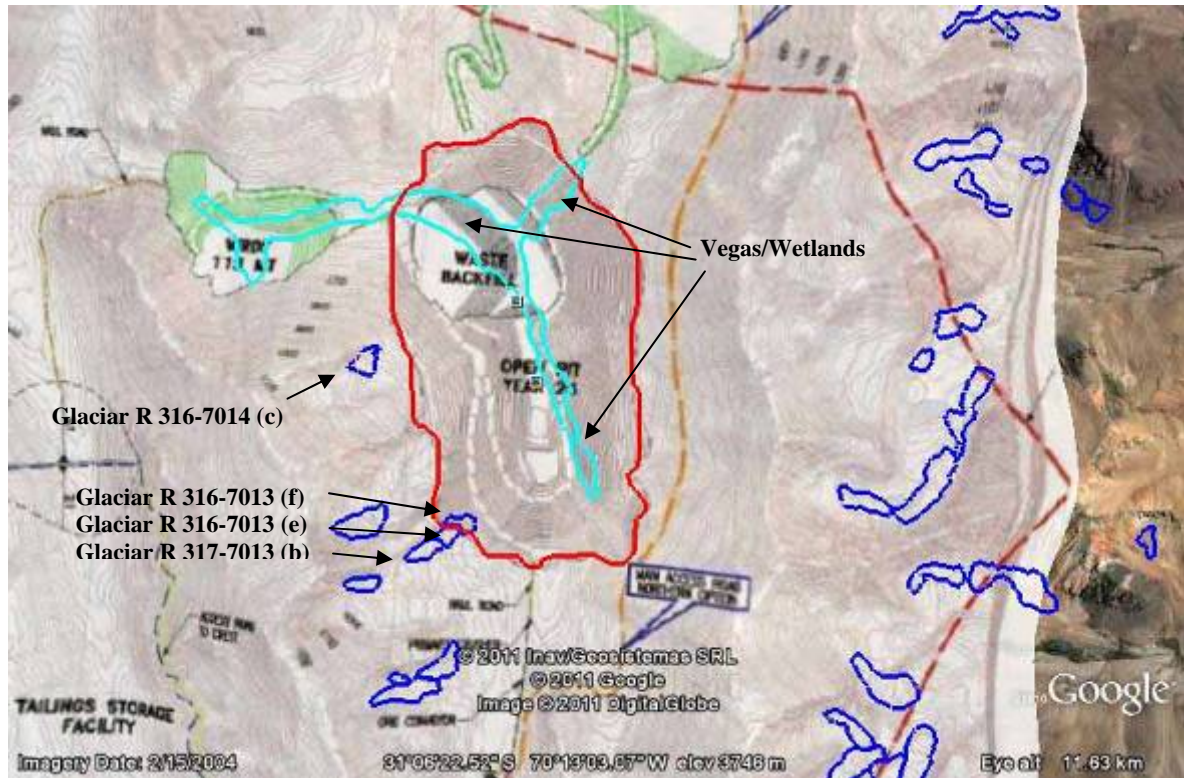
Pit Location in Conflict w/Vegas and Glaciers
