Special Report – Glaciers and Mining Series

**Massive Landslide of Waste Pile Site
at Veladero in Argentina (Barrick Gold)**

by Jorge Daniel Taillant
The Center for Human Rights and Environment
jdtailant@cedha.org.ar

October 20, 2011
Córdoba, Argentina

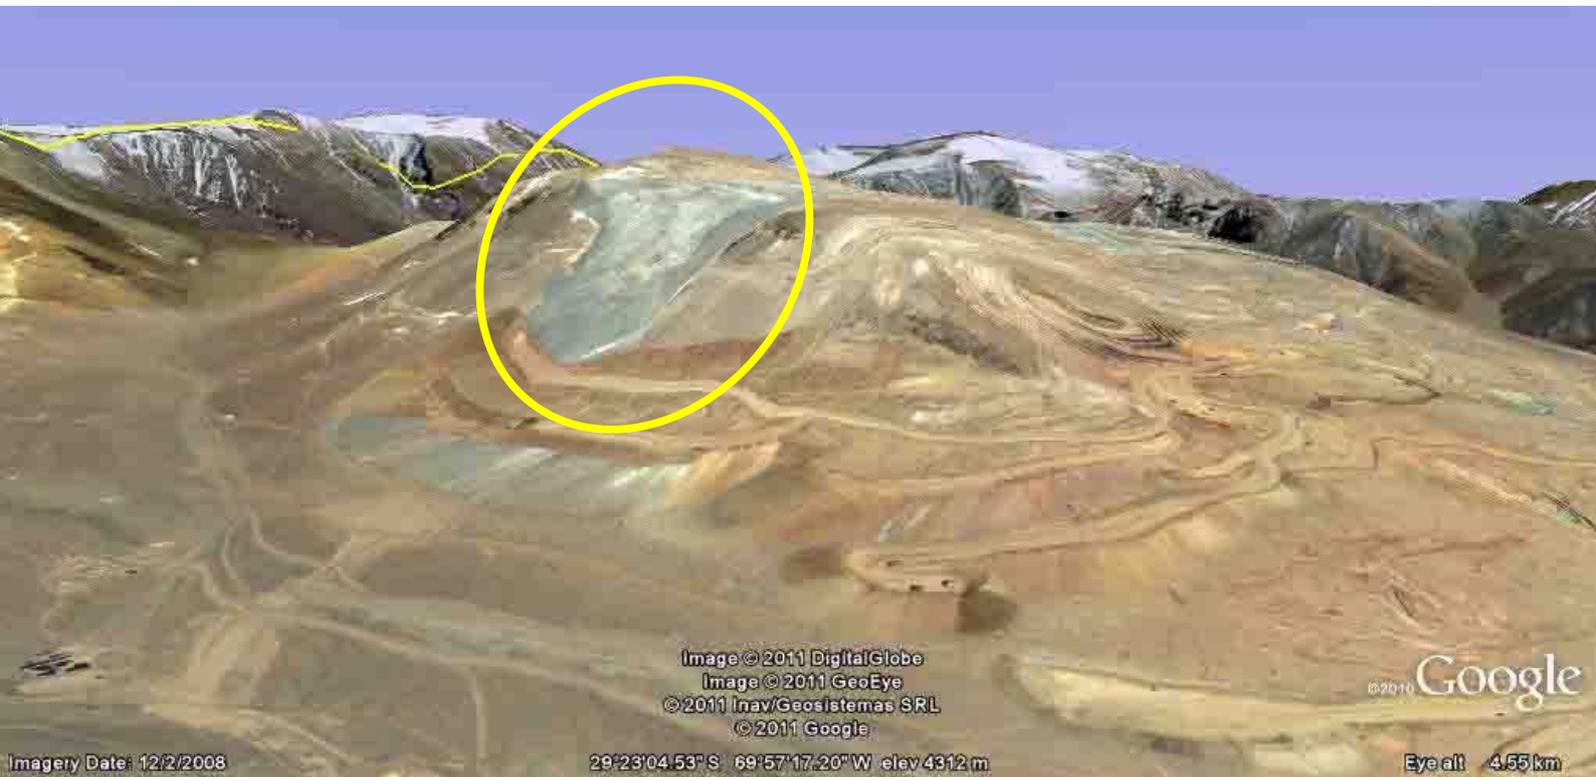
Yellow Oval, according to Geologist Juan Pablo Milana, shows massive landslide at Barrick's Veladero Mine in 2008

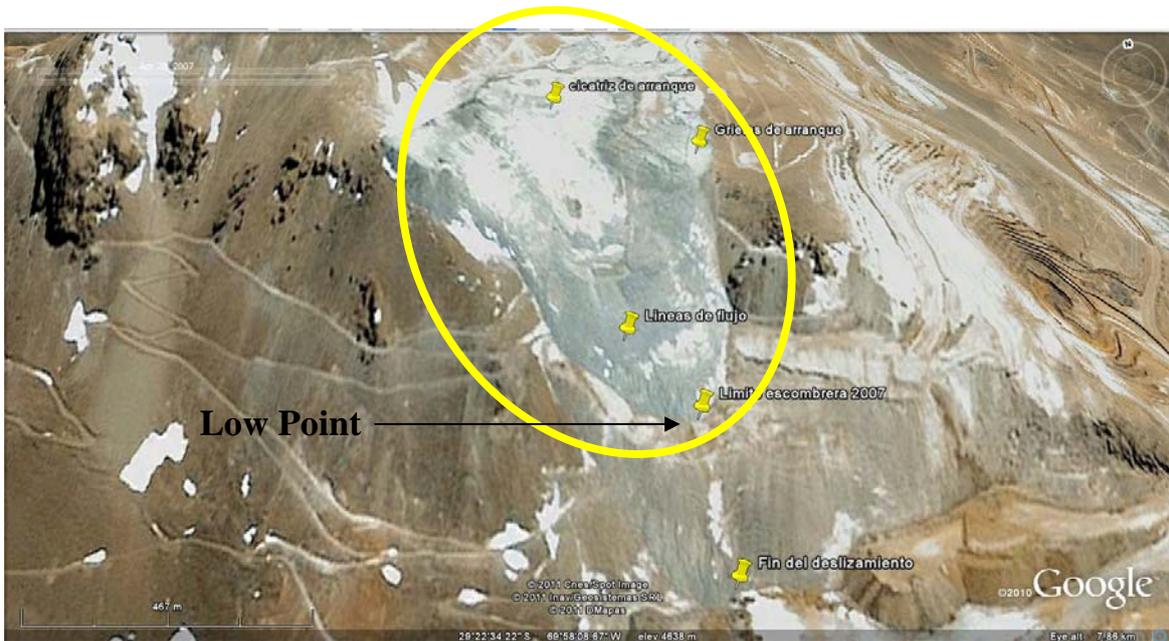
In the next image we see a picture of the waste pile site in 2007, before the collapse. The waste pile is in grey, contrasting with the brown of the surrounding area. We've indicated the site with a yellow oval. Note Milana's lowest yellow marker, indicating the lower limit of the pile.

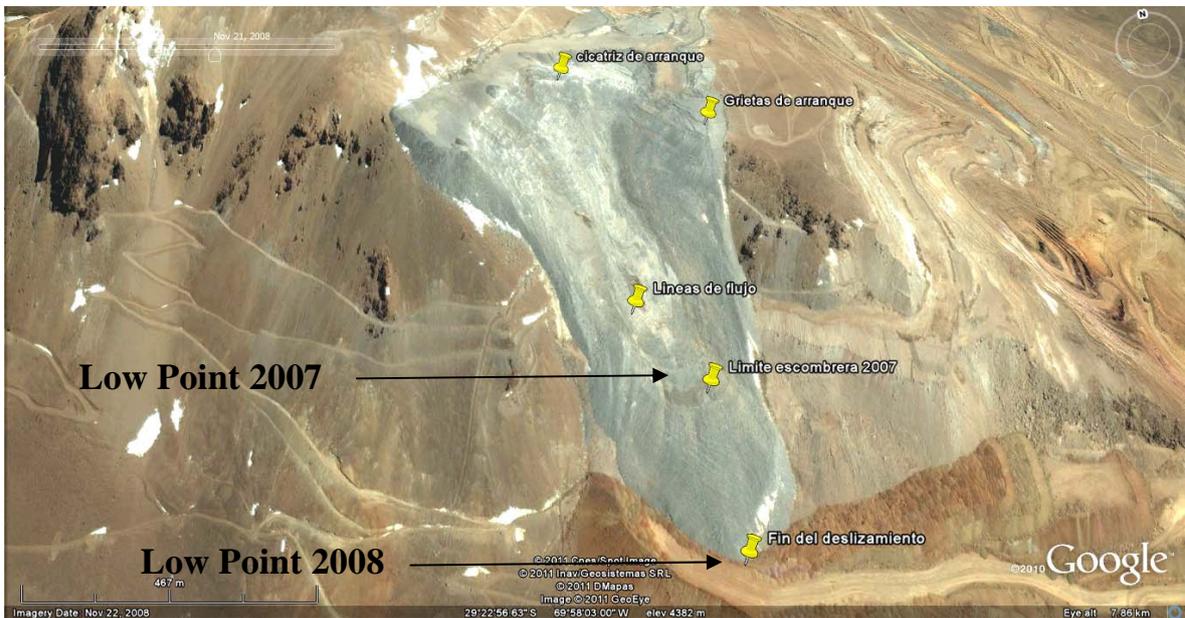
The next image shows the pile following the collapse, with its lower limit substantially lower than in the previous image.

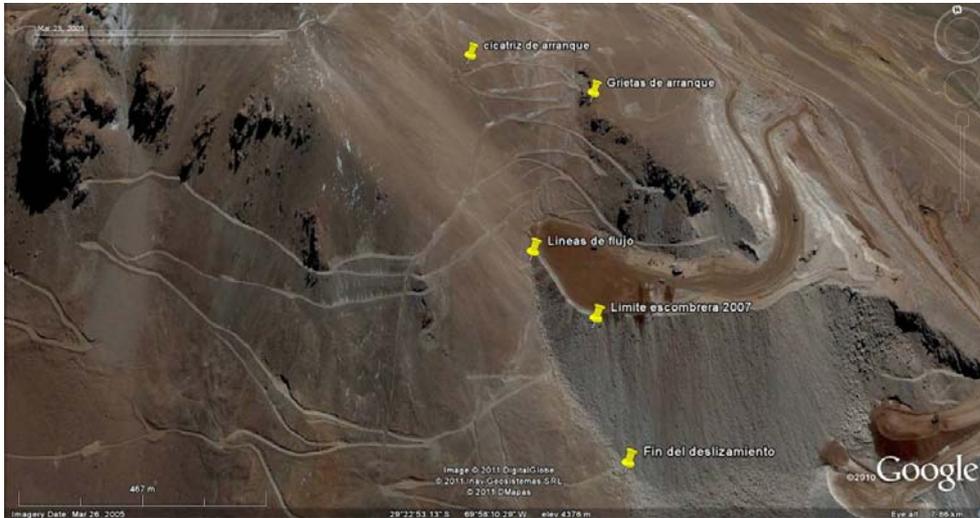
The third image, below, shows the site prior to Barrick' introduction of a waste pile, in 2005. Milana had informed authorities that the site contained sensitive permafrost zone, which back then were not protected by national law, as they are now under the National Argentine Glacier Protection Act. Nonetheless, the Provincial Glacier Protection Law leaves permafrost out. This is one of the

important differences between the laws, and why Barrick has expressed its preference for the provincial law, since situations like these would not be tolerated.
