**SPECIAL REPORT**  
**Glaciers and Mining Series**

**Los Azules – Minera Andes**  
**(McEwen Mining of Canada)**

**Risks and Impacts to Rock Glaciers**  
**and Periglacial Environments**

**San Juan, Argentina**  
**May 2012**

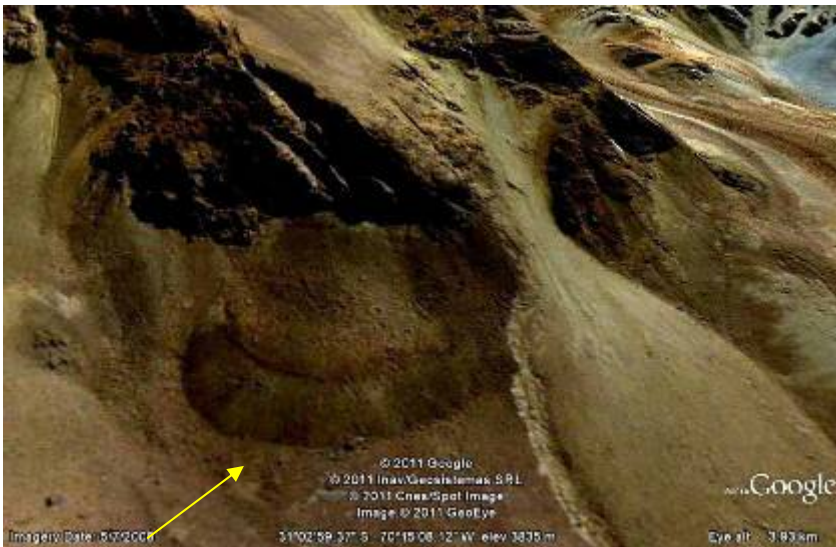
Rock Glacier from the Los Azules Area is Typical of High Andes Rock Glaciers

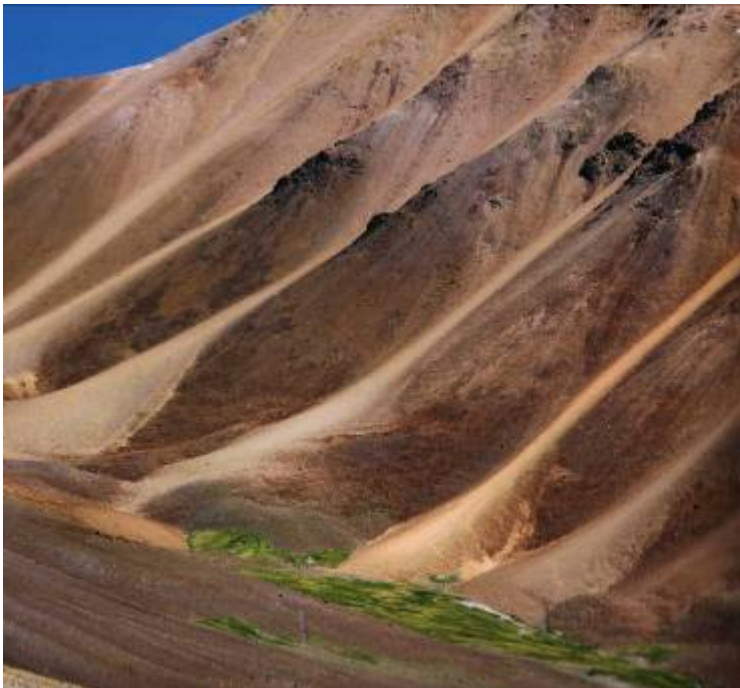
Vegas (wetlands) form in Los Azules valley due to ice melt from glaciers, permafrost and seasonal snow melt. Photo: JP Milana

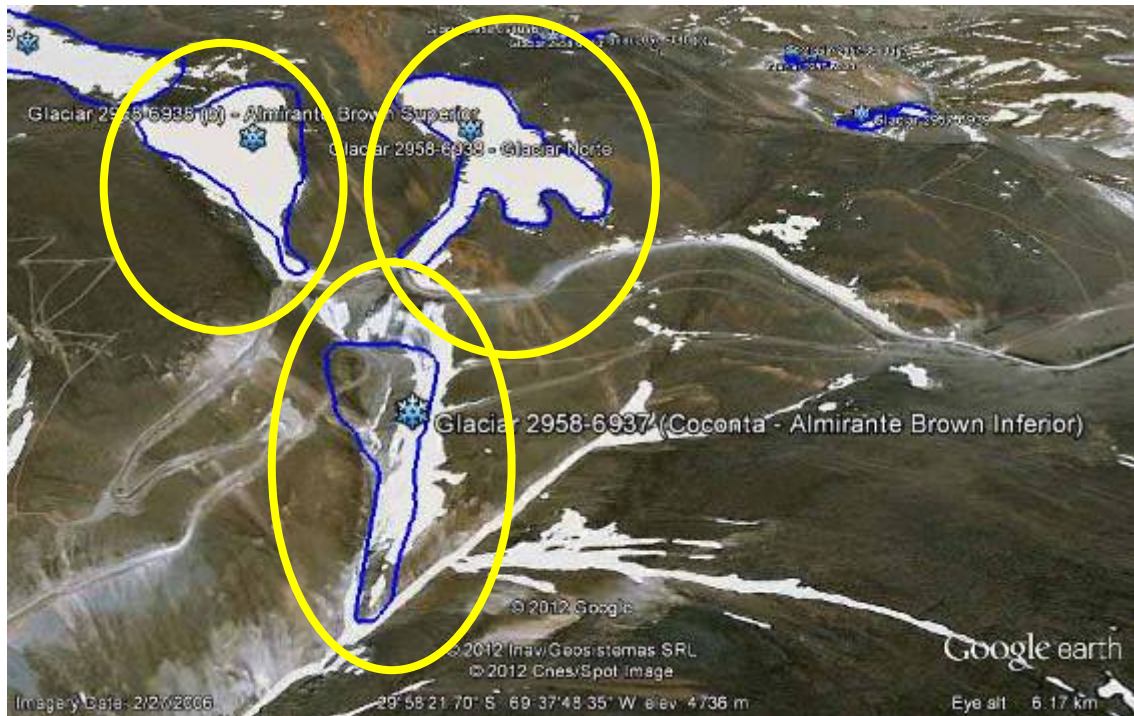
The Almirante Brown Superior and the Inferior Glaciers as well as the North Glacier, at one time were probably united; today the Inferior is extinct and the others are in peril of disappearing due to Barrick's access road to Veladero.

While we do not have images prior to Barrick's unfortunate choice of the placement of its road, we can logically conclude, firstly, that the two glaciers Almirante Brown Superior and the North were at some point in time linked to the Almirante Brown Inferior. Now Veldero's access road dissects the glaciers at the point where they were linked. The ice of the two glaciers probably advanced naturally to fill the crevasse we can see below the road. This crevasse is over 100 meters deep and probably contained an enormous quantity of ice.

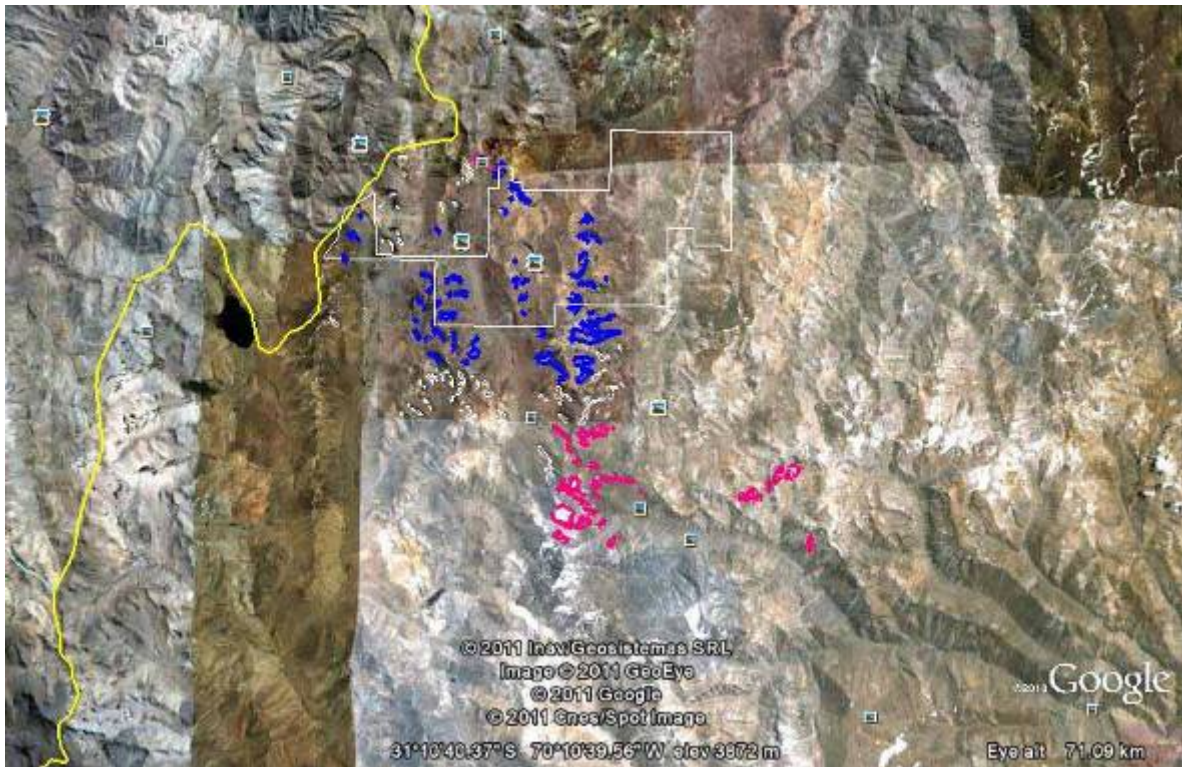
In our own review of satellite imagery, we have identified 226 glaciers, including uncovered glaciers and rock glaciers in the project vicinity. These are all “ice glaciers”, debunking the statement on McEwen Mining’s website suggesting that there are no ice glaciers at the project site. We reproduce a *Google Earth* image below showing the location of these glaciers, with 79 rock glaciers in the project’s formal area (represented as blue polygons), 49 rock glaciers not in the project area but along the access roads to Los Azules (represented as magenta colored polygons), and 98 rock glaciers that are neither in the formal area or near roads, but that are in the project’s general vicinity at potential impact area (represented as white polygons).

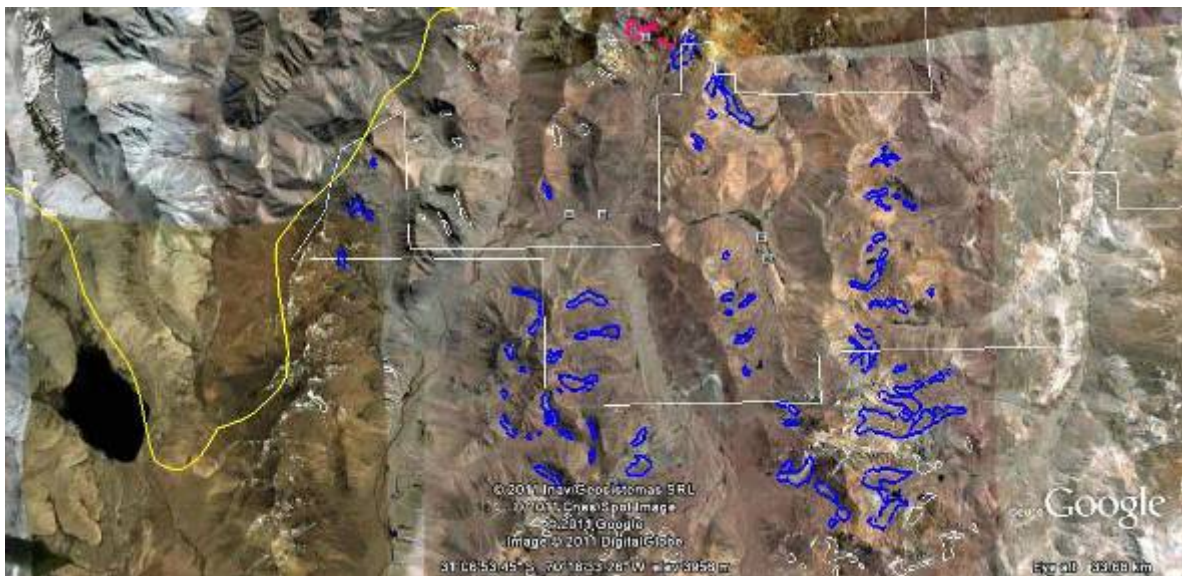
The same image brought closer to view the glaciers in the project area (blue polygons):

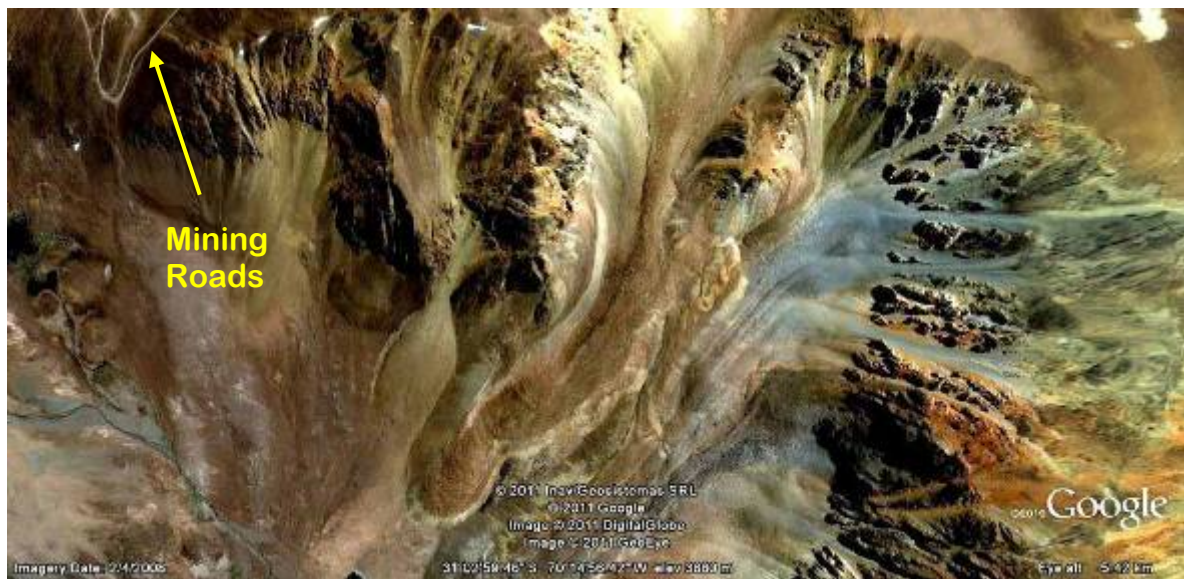
We see here several beautiful and well-developed rock glaciers (ice glaciers) in the Los Azules project area, coming off the mountain in a flowing pattern with tongue-like terminations. We also see a Los Azules mining exploratory road encroaching into the image at the top left corner. Tilting the image with Google Earth's 3D function (found in the upper right corner of the screen, by pressing on the northern arrow and then using the up/down/left/right keys) we can position this image in 3D to see these majestic glaciers in their full breadth and form. We can also see vegas (wetlands) at the foot of the glaciers.

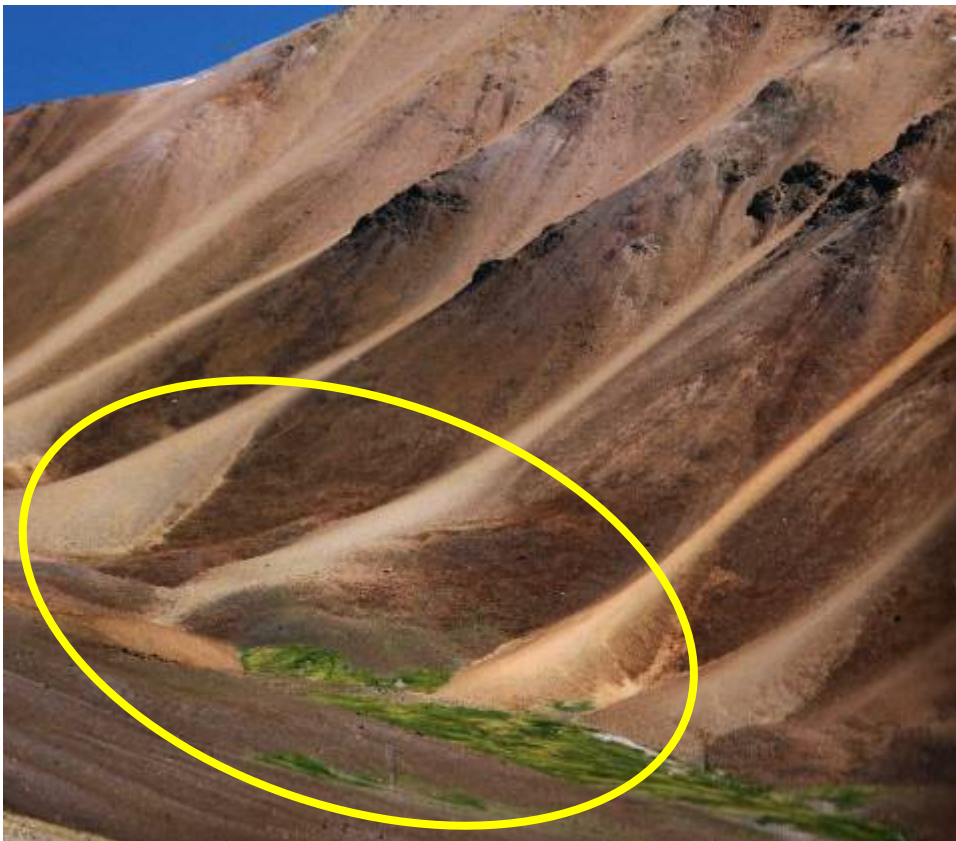
In the following image, which we had already reproduced above, we see the relationship and importance of permafrost terrain to local ecosystems. The vegas formed at the foot of this mountainside near the Los Azules project receive a regular discharge of water from seasonal thawing ground ice in upslope permafrost terrain. This photograph is extracted from Juan Pablo Milana's book, "Ice and Desert" (in Spanish, Hielo y Desierto), and the caption reads: "Talus Cones, separated by mountainsides with crawling permafrost. Note that the vegas of this valley are only nurtured by permafrost".<sup>30</sup>

Permafrost (marked by oval) is a key source of water for wetlands in much of Los Azules area.  
Photo: JP Milana

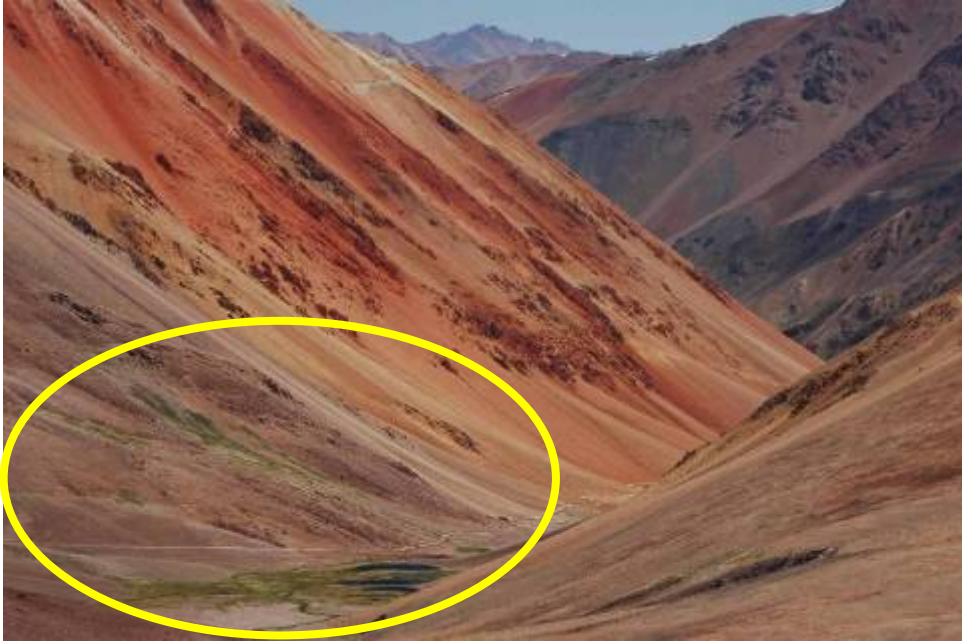
Oval shows more Permafrost feeding vegas/wetland lands below in the Los Azules area.  
Photo: JP Milana

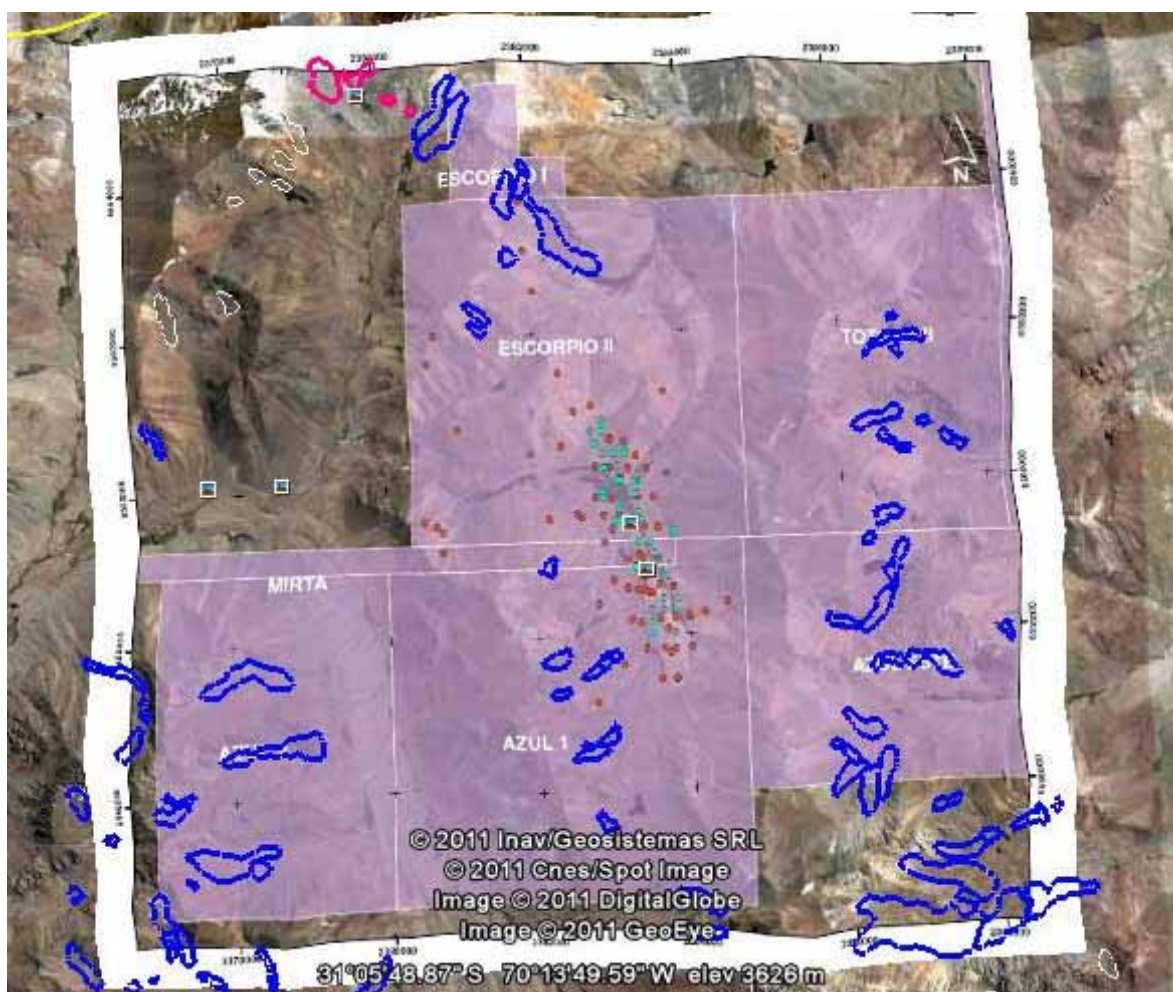
Drilling at Los Azules with Superimposed Google Earth Image Showing Glacier Mapping

Zoomed-in images show drill sites that are dangerously close or at rock glacier sites, particularly glaciers (as cited in our inventory in the annex), 313-7014, 313-7014 (b), 313-7014 (d), 314-7014, 316-7013(f), 316-7013 (e), and 317-7013 (b). These glaciers can be viewed in *Google Earth* by copying the location coordinate from our inventory in the annex into the *Google Earth* search box. The reader can also download the drilling map transparency image which is also viewable in *Google Earth*. With the transparency lever, which will appear once the map is loaded in *Google Earth*, you can make the map more or less transparent and thus compare the drill site with the rock glacier and other natural elements visible in *Google Earth*. Below is a reproduction of what the reader will see on *Google Earth*. The yellow ovals indicate where the transparency lever is. Be sure to click the pointer on the map folder in left pane, otherwise the transparency level will not work!

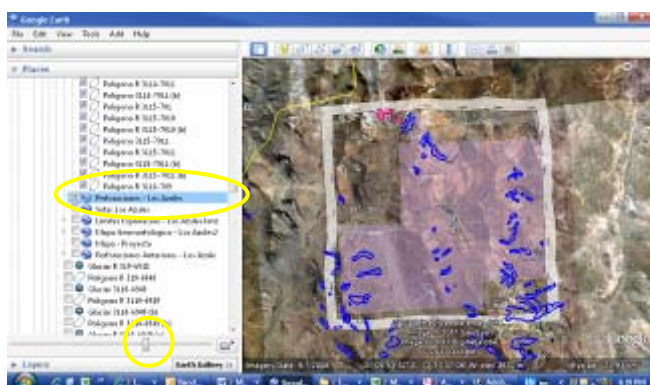
Superimposed Drilling Map and Google Earth Image Reveals Drilling adjacent to Four Rock Glaciers

While the two images we reproduce don't show that the drilling has taken place *exactly on a rock glacier surface*, we cannot be sure if this surface or any of the other numerous drill sites contain permafrost. We can however deduct from the commentary by the subcontractor on page 78 of Minera Andes' technical report indicating that drilling was made difficult by the presence of rock glaciers, and this suggests to us that indeed at these drill sites, rock glaciers were indeed perforated.

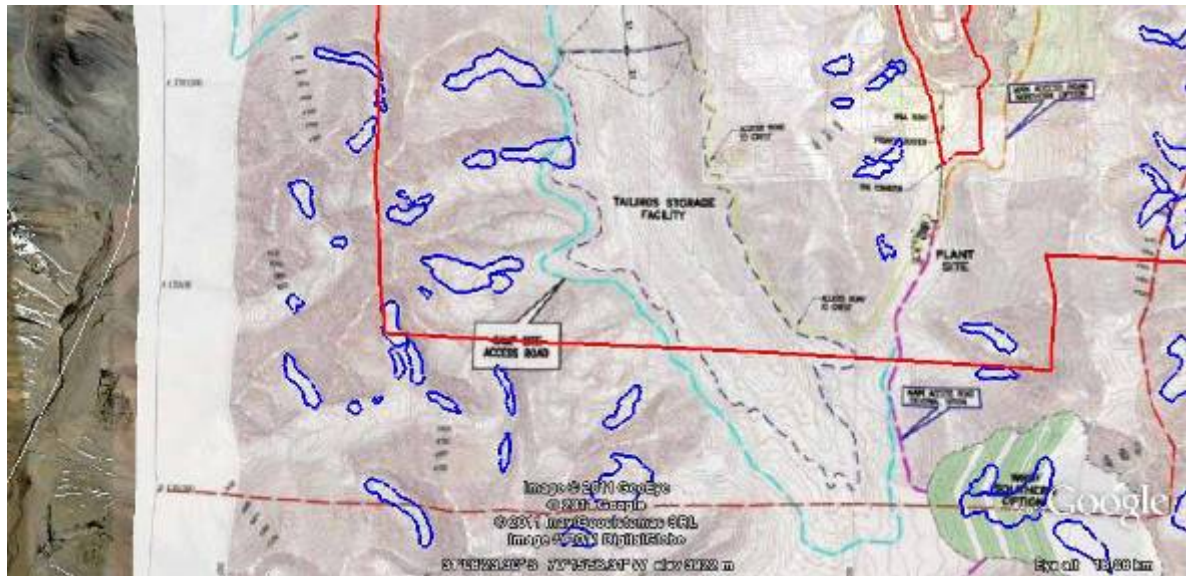
Zoomed in versions of this transparency in *Google Earth* show a clear conflict between the waste site choices and existing rock glaciers. We can presume there is also permafrost area at these sites.

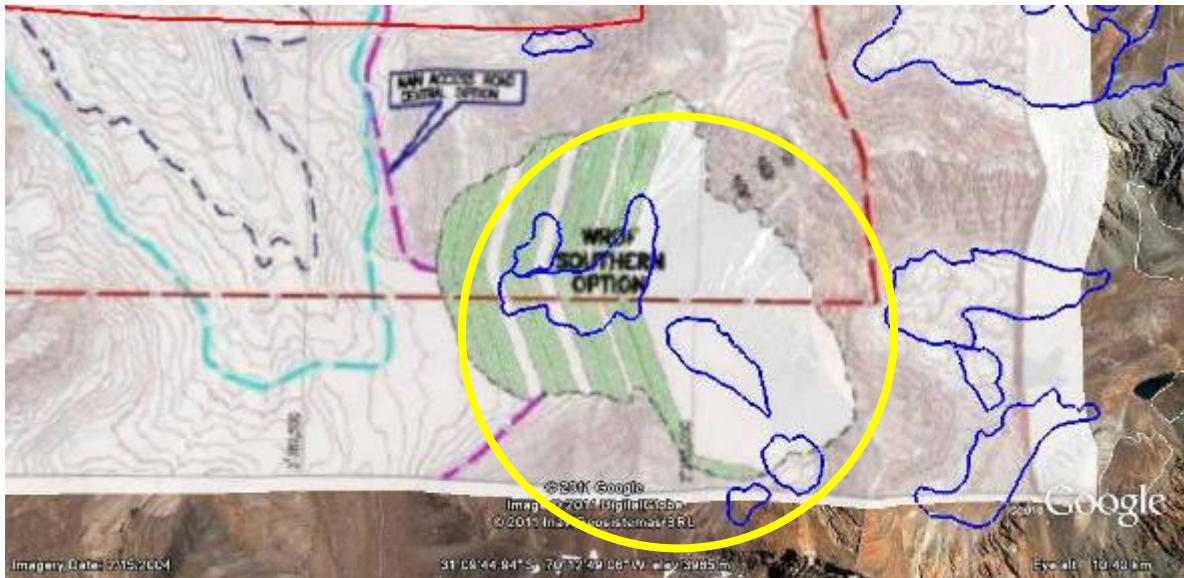
Option II for the waste facility is no better than Option I, in fact, it is worse. We see five glaciers impacted by the site choice, three of which are entirely in the waste site (rock glaciers 319-7013, 319-7012, 3110-7012 (b)), one is straddled on the edge (rock glacier 3110-7012 (c)), while the fifth is adjacent to it (rock glacier 3110-7012 (d)).

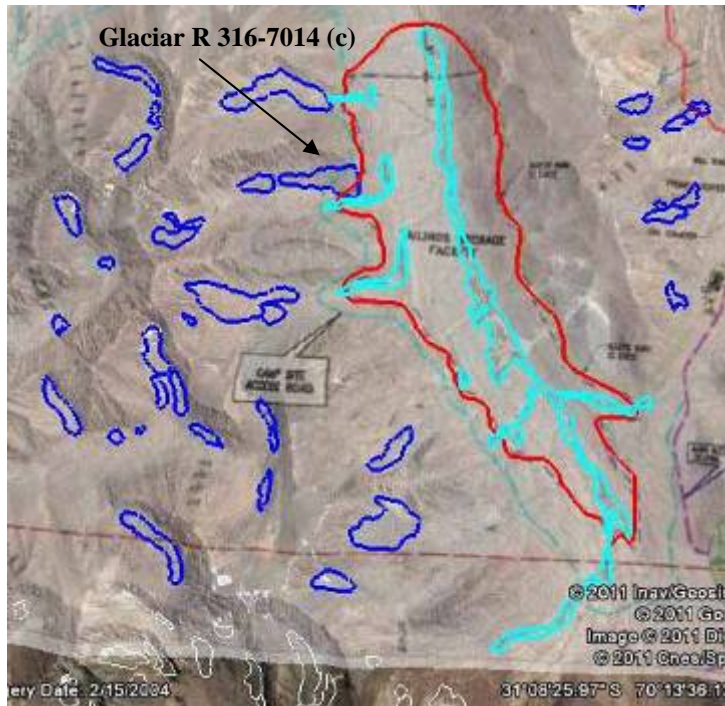
If we examine the Tailing Storage Facility (red polygon), we also find conflicts both with glaciers as well as with vegas presence, which again, may indicate that there is extensive permafrost in the area.

The image to the left shows clearly extensive vegas presence inside the TSF, as well as significant rock glacier presence along the western end of the valley (with glaciers particularly close along the most northern end of the TSF). One of the glaciers, Glaciar R 317-7016 (c).
